INFORMATIONAL GUIDE TO THE **REPAIRING** **& RE-SURFACING** OF STRUCTURALLY CRACKED **POOLS & SPAS**

This informational guide will explain the causes, concerns & repairs associated with structurally cracked pools and spas.

Building Pools in Hillside Areas

STRUCTURAL REPAIR OPTIONS

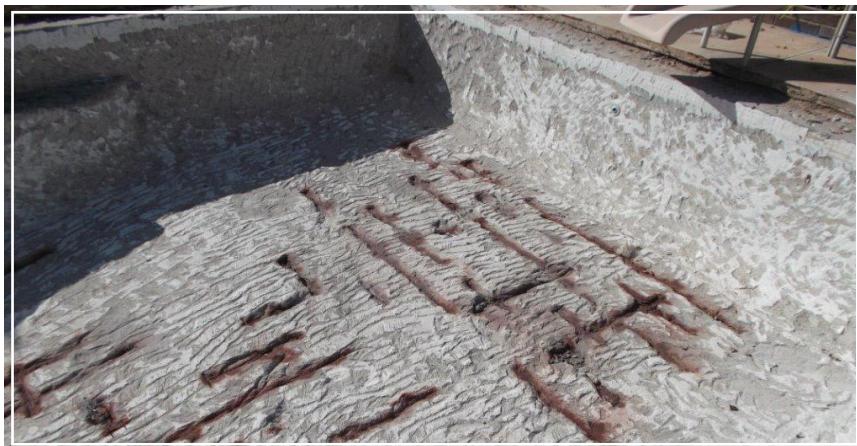
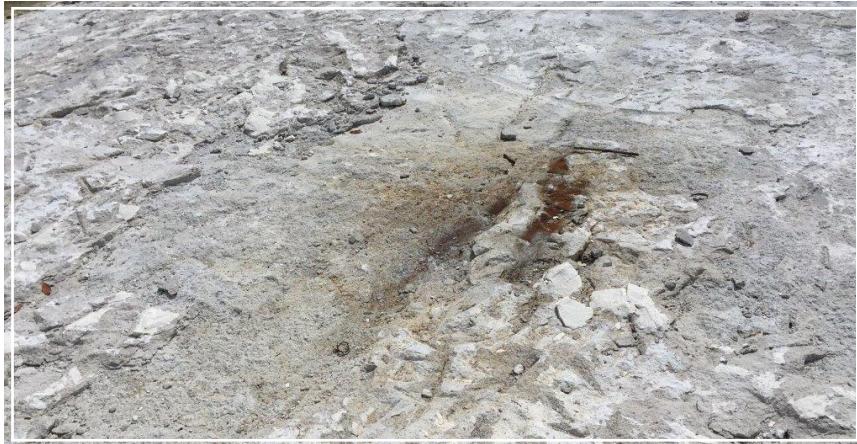
Combination
of thin
rebound
gunite &
steel placed
too close to
surface.

- Low PSI gunite/shotcrete installed at time of installation
- The gunite/ shotcrete was installed too thin
- Defective and weak rebound gunite/shotcrete was reused during the pool construction
- Improperly placed structural steel at time of construction
- Improper expansion / separation joints around the pool deck to pool bond beam area
- Long plumbing runs placed inside the gunite/shotcrete structure
- Improper engineering at time of construction

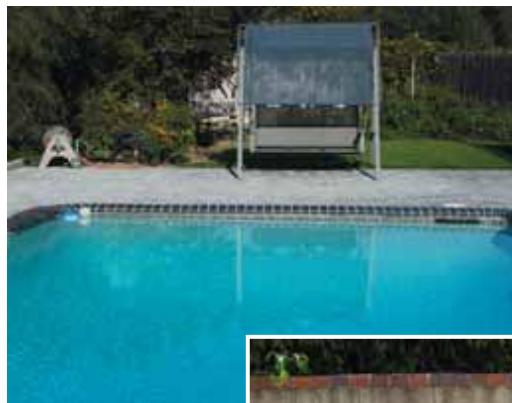
Pool rotates and becomes out of level. Note water line at tile on left slope side versus right side.

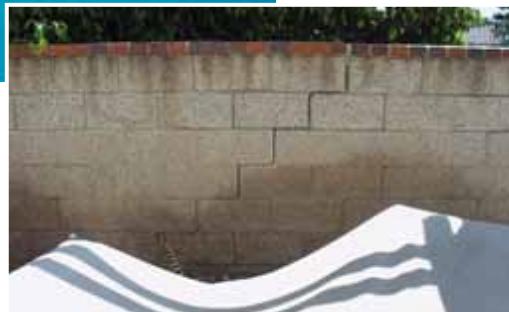
Side property line walls will crack usually 10 to 15 ft. from the slope.

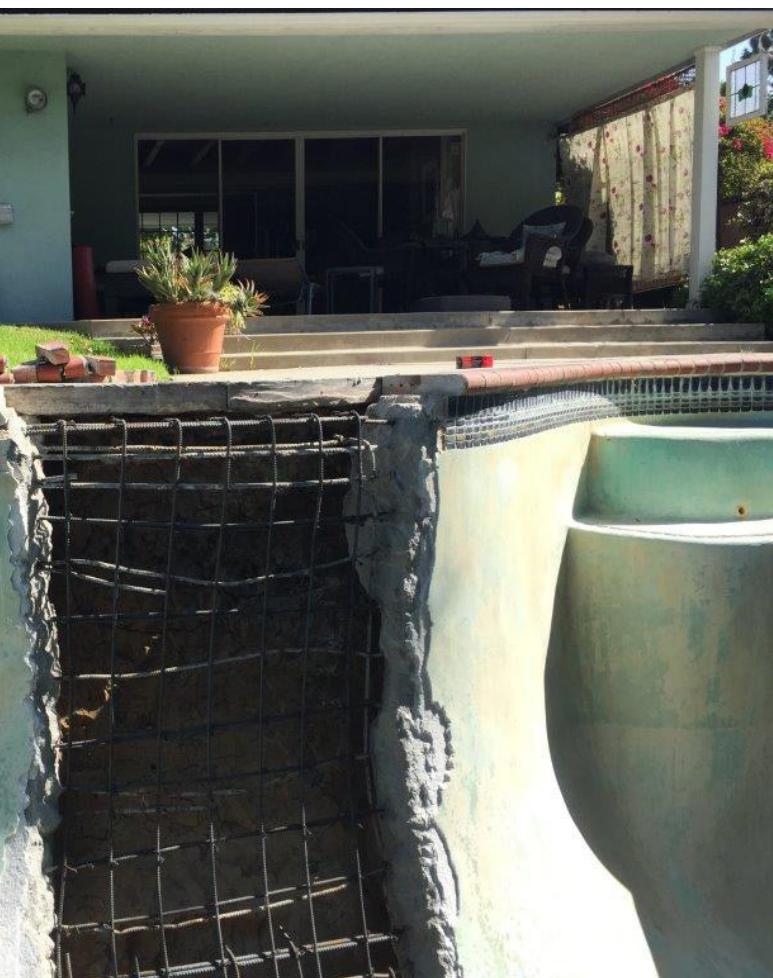
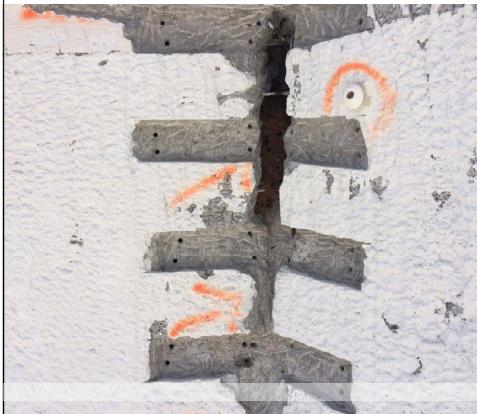
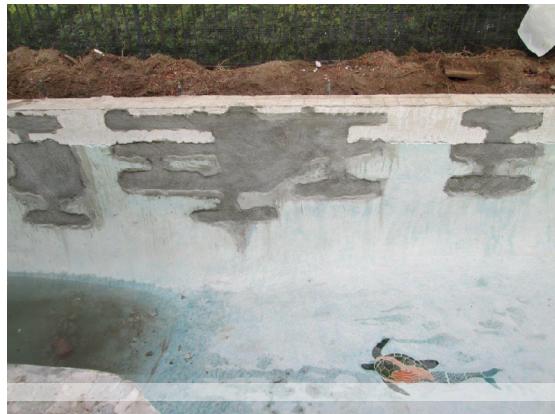
Option 1

The best type of crack repair for swimming pools involves removing the gunite / shotcrete on either side of the crack for a total distance between 18-24" wide. The removed gunite is replaced with higher strength material (not to exceed 4,500 PSI) and placed at least 1 ½ times the thickness of the material removed. Any deteriorated reinforcing steel should be replaced.

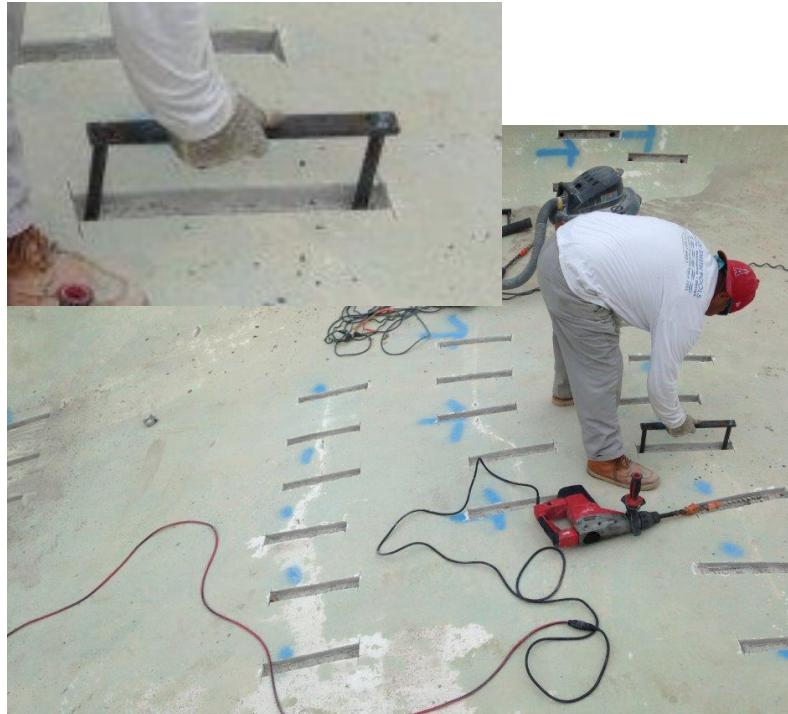
Option 3

This last method is to install large 12-18" long steel staples with 6" pins at each end. These staples are installed every 12-18" perpendicular with the crack. These staples are installed using high strength epoxy, followed with a high pressure epoxy injection of the crack itself. The staples are covered with water resistant cement.

Each of these repair methods comes with a different cost point. The only repair method we at Alan Smith offer is the staple and epoxy injection. Since we do not have any control of how the pool was built, or if any geological soil movement is occurring, we offer NO warranty on Pool Shell Re-Cracking. We simply cannot warranty what we cannot control.

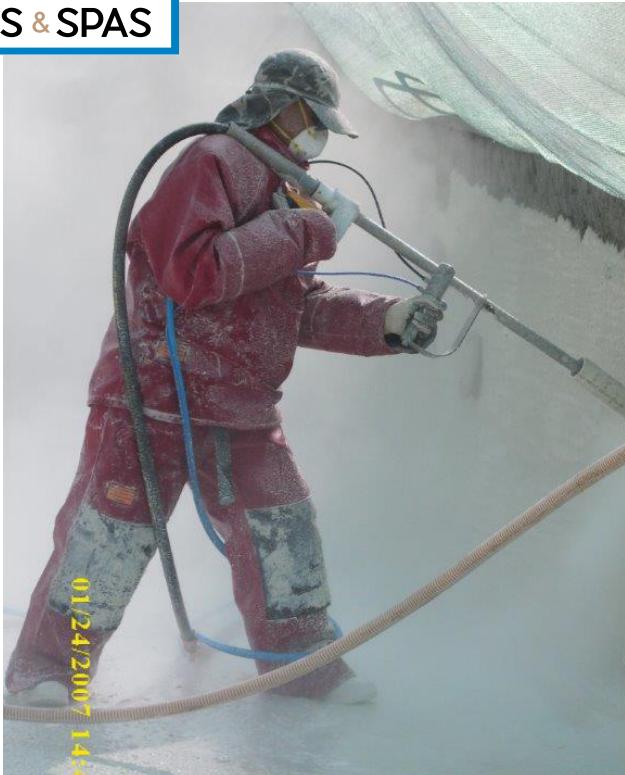
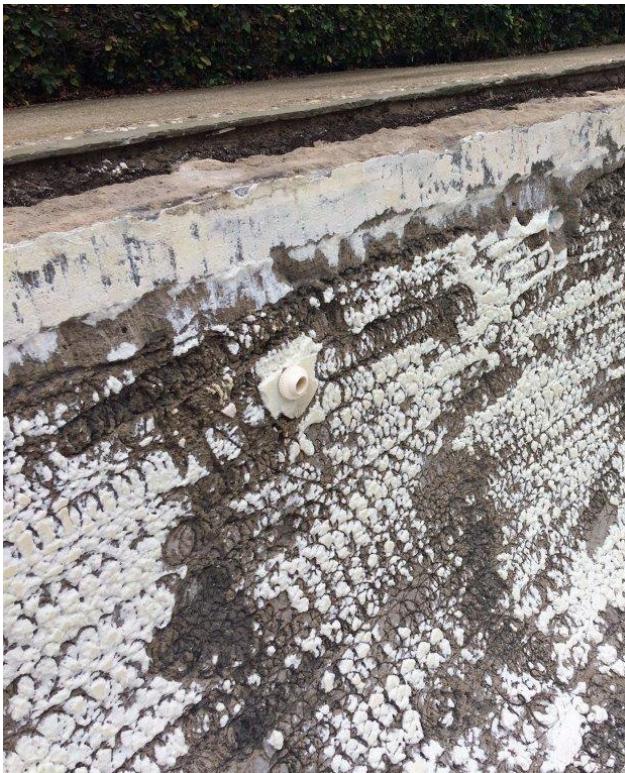
Method 1

The first method is to jack hammer or strip the old pool plaster material off using pneumatic or electric jack / chipping hammers. We believe and know that this method will remove some of the existing pool gunite material and cause micro bruising of the already compromised pool shell. We strongly do not recommend this method.

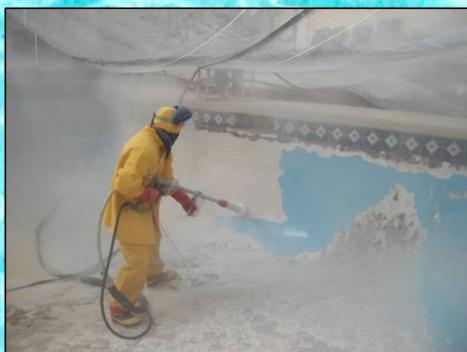
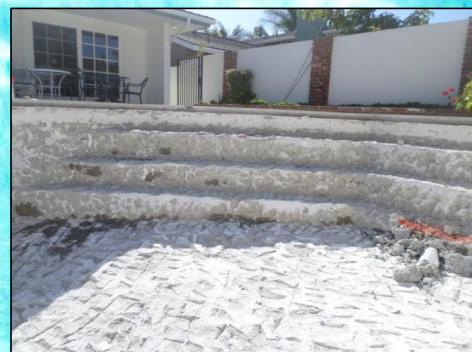
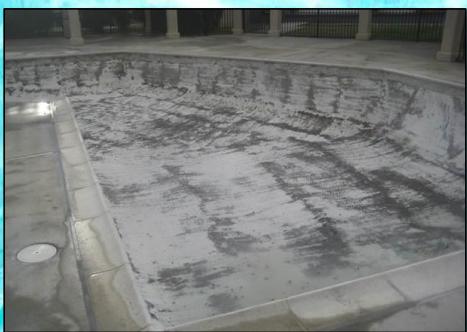
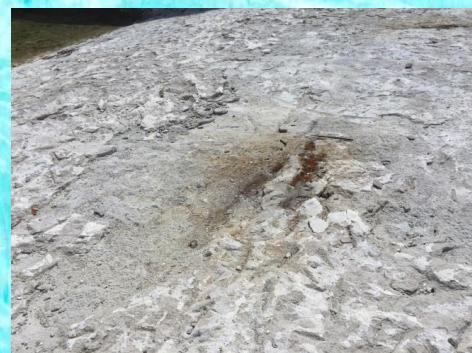
Hydro Blasting vs. Stripping

- **Hydro Blasting cuts plaster with high pressure water**
- **Hydro Blasting leaves an excellent profile for new material bonding (ASP gives 10 year warranties)**
- **Hydro Blasting does not impact and bruise the gunite substrate**
- **Hydro Blasting does not expose structural steel**
- **Hydro Blasting leaves a surface that is uniform for new product placement (No highs and lows)**
- **Hydro Blasting does not cause shell trauma**

To minimize damage to the pool's shotcrete substrate and ensure long-term performance of the resurface, hydro-blasting is the preferred surface preparation method. Hydro-blasting is most effective at preventing micro-cracking and surface bruising of the substrate that often results from using impact hammers.

It is important to differentiate between high-pressure hydro-blasting and pressure washers. High pressure hydro-blasting is capable of cutting into concrete surfaces. Depending on the concrete substrate hardness, the required pressure can vary between 10,000 and 40,000 psi, substantially greater than pressure washers. Surface preparation must be preceded by removal of any layers of deteriorated or unsound shotcrete down to layers of sound shotcrete before the surface preparation takes place.
